REPORT DOCUMENTATION PAGE		READ INSTRUCTIONS BEFORE COMPLETING FORM
1. REPORT NUMBER	2. GOVT ACCESSION NO.	3. RECIPIENT'S CATALOG NUMBER
CESAM/PDFC-88/03

4. TITLE (and Subtitio) US Army Corps of Engineers Reconnaissance Report North Coast of Honduras Flooding		5. TYPE OF REPORT & PERIOD COVERED Reconnaissance Rpt.
		March 1988

6. PERFORMING ORG. REPORT NUMBER
7. AUTHOR(a)		8. CONTRACT OR GRANT NUMBER(s)
Mathew M. Laws, III		
9. PERFORMING ORGANIZATION NAME AND ADDRESS U.S. Army Engineer District - Mobile Coastal Section, Planning Division (CESAM-PD-FC) P.O. Box 2288, Mobile, AL 36628-0001		10. PROGRAM ELEMENT, PROJECT, TASK AREA & WORK UNIT NUMBERS

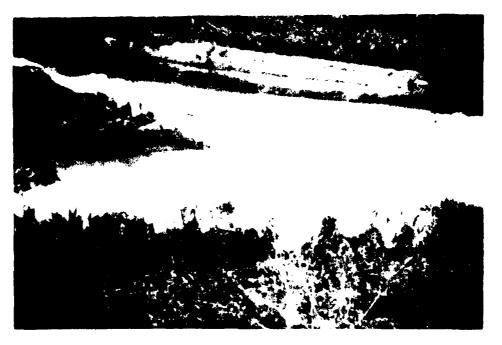
Looking north at mouth of Canal Melcher and Rio Ulua (Canal Melcher in foreground flows west).

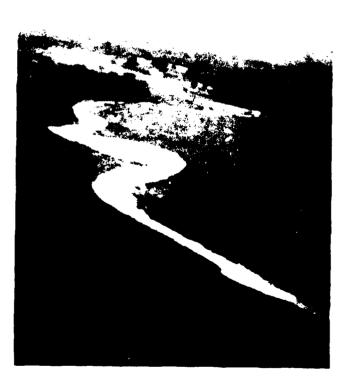
Looking south at the Rio Chamelecon and the Sula Valley from the vicinity of the town of Los Pizotos.

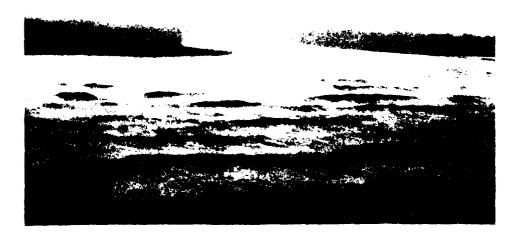
Looking south at the mouth of both the Rio Chamelecon and Canal Del Cruce (Stays open to Caribbean all year).

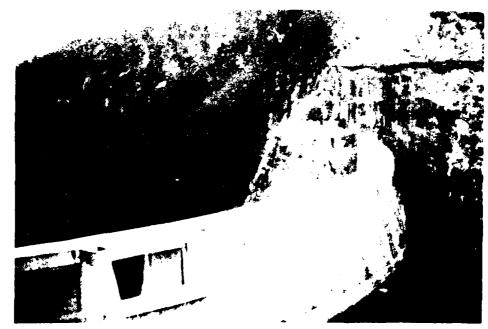
Looking east at the top of the El Cajon dam from the upstream side (Note: Emergency spillway sills in foreground).

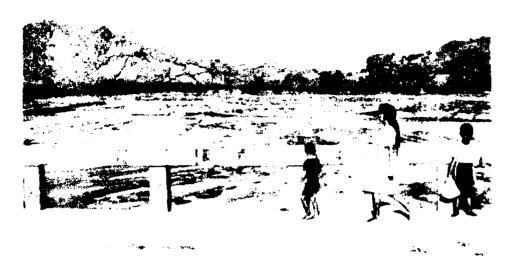
Looking west (upstream) at the Rio Choloma from the Federal Highway One bridge crossing at the town of Choloma.

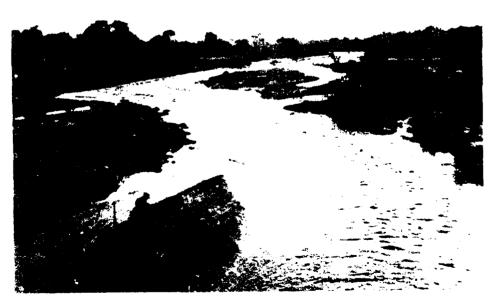
Looking east (downstream) at the Rio Choloma from the Federal Highway One bridge crossing at the town of Choloma.

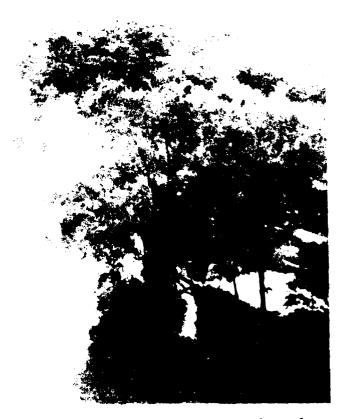
Looking west at the Rio Lean channel under flood conditions near Colorado.

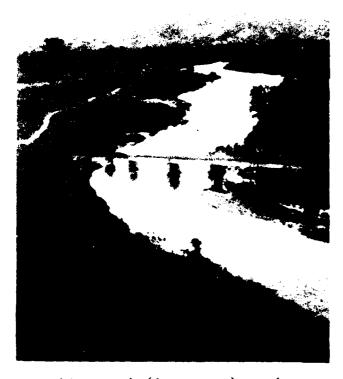
Looking north (downstream) at the Rio San Juan channel and the railroad bridge crossing in the vicinity of the town of La Soledad.

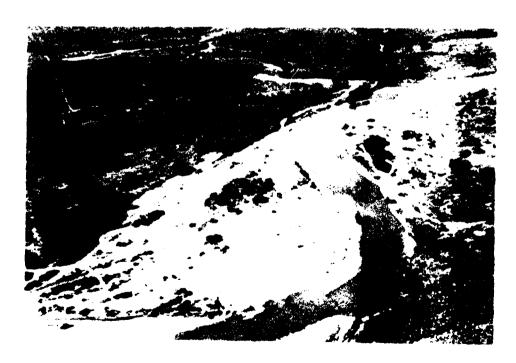
Looking generally west (upstream) at the Rio Aguan channel in the vicinity of the town of Saba.
